SUBJECT: Transmittal of the Operable Unit (OU) 5-05 Stationary Low Power (SL)-1 Burial
Grounds and OU 6-01 Boiling Water Reactor Experiment (BORAX)-I Buried
Reactor Annual Inspection Report - (EM-ER-01-077)

OU 5-05, SL-1 Burial Ground and OU 6-01, BORAX-I Buried Reactor 2001 Annual Inspection Summary

BORAX-I ENGINEERED BARRIER

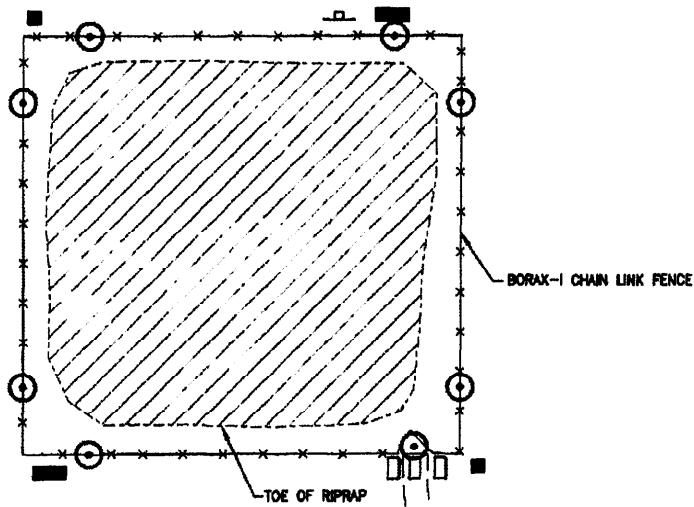
- BORAX-I The BORAX-02 CERCLA sign needs to be updated. The present perimeter fence size is 48×51 m (158×165 ft), while the CERCLA sign has the preremedial action dimensions of 30×30 m (100×100 ft).
